# Shoreland and Shallows Survey

## Deer Lake, Polk County Wisconsin

July 2021

Data collected by: Bay Area Environmental Consulting, Ashland WI

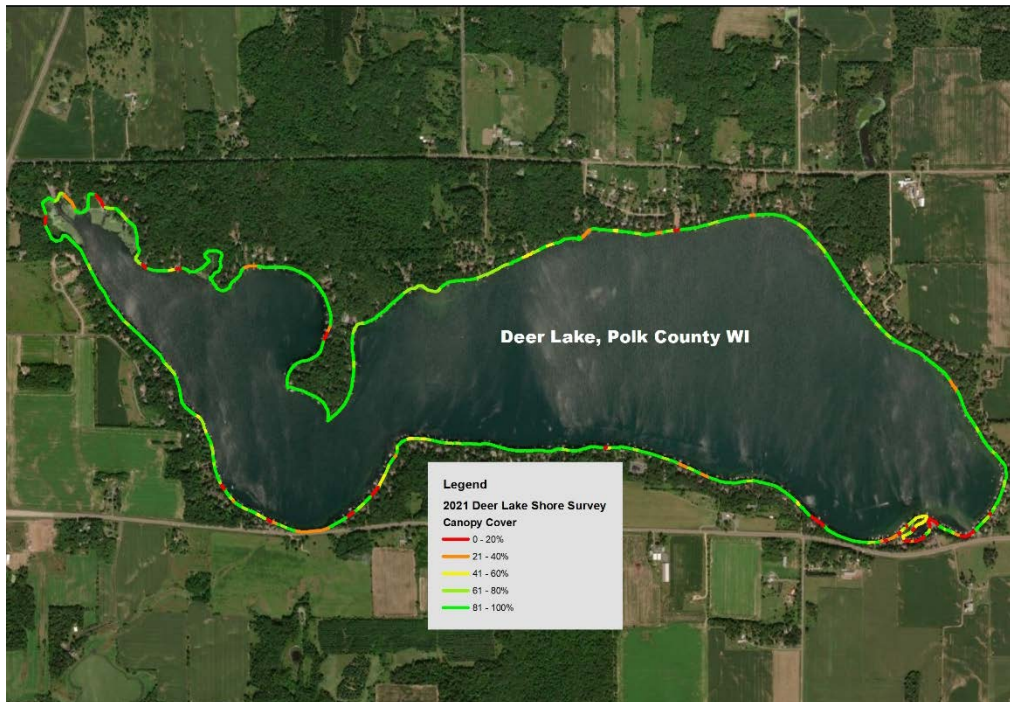
Canopy cover: Less canopy cover can increase runoff and increase erosion.

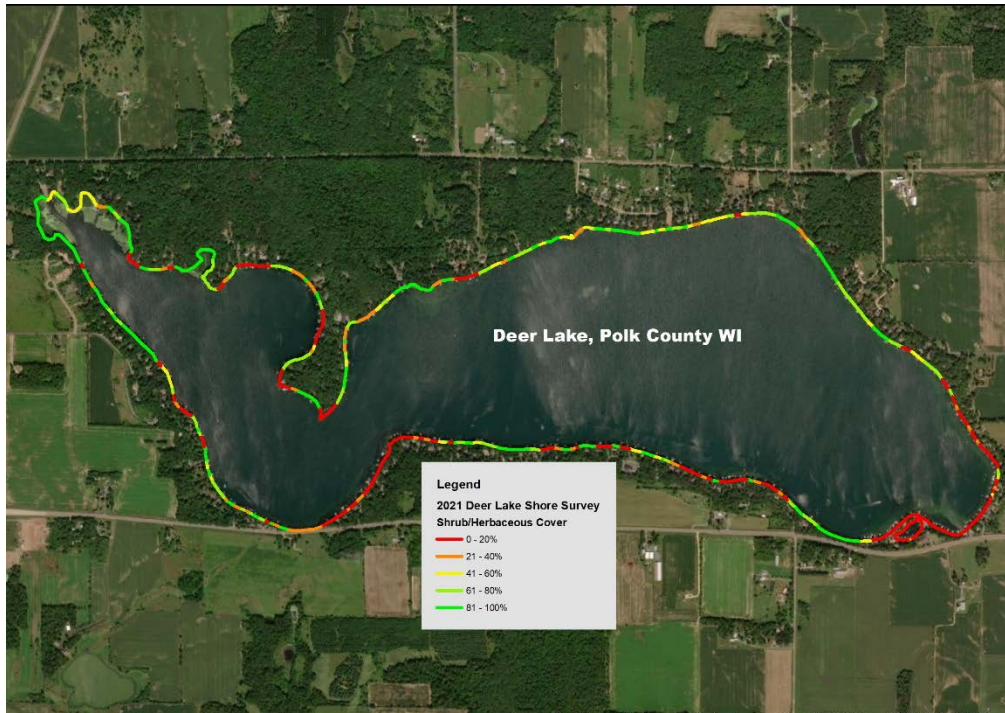
Herbaceous/Shrub Cover: This indicates natural ground cover. The less natural ground cover means more, less desirable cover, increasing runoff and nutrients in that runoff.

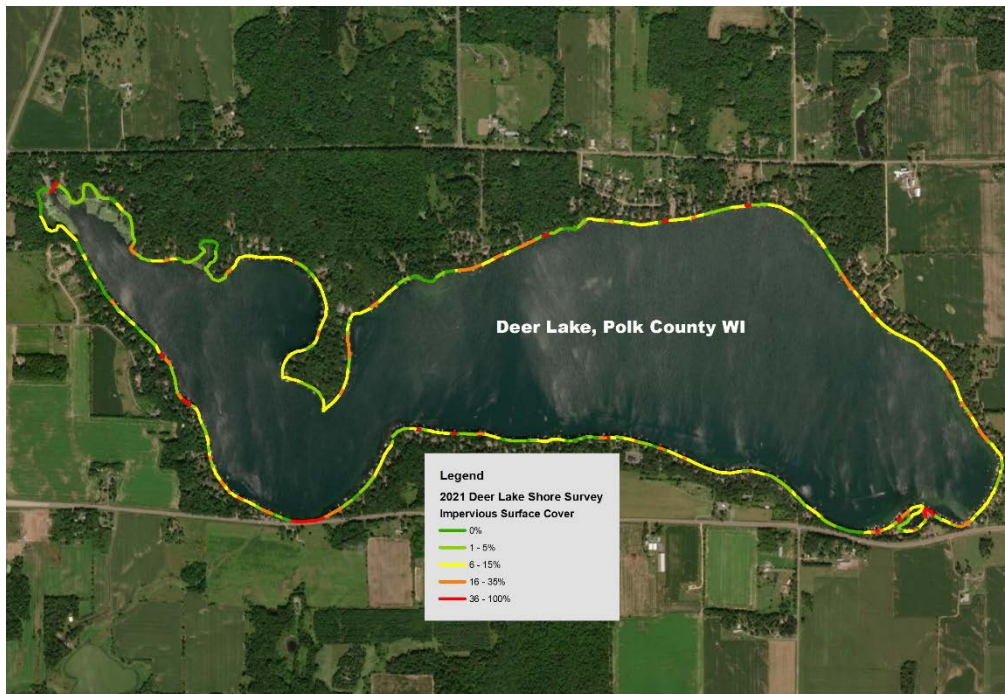
Impervious surface cover: Impervious surfaces do not allow for the infiltration of precipitation. This increases runoff immensely.

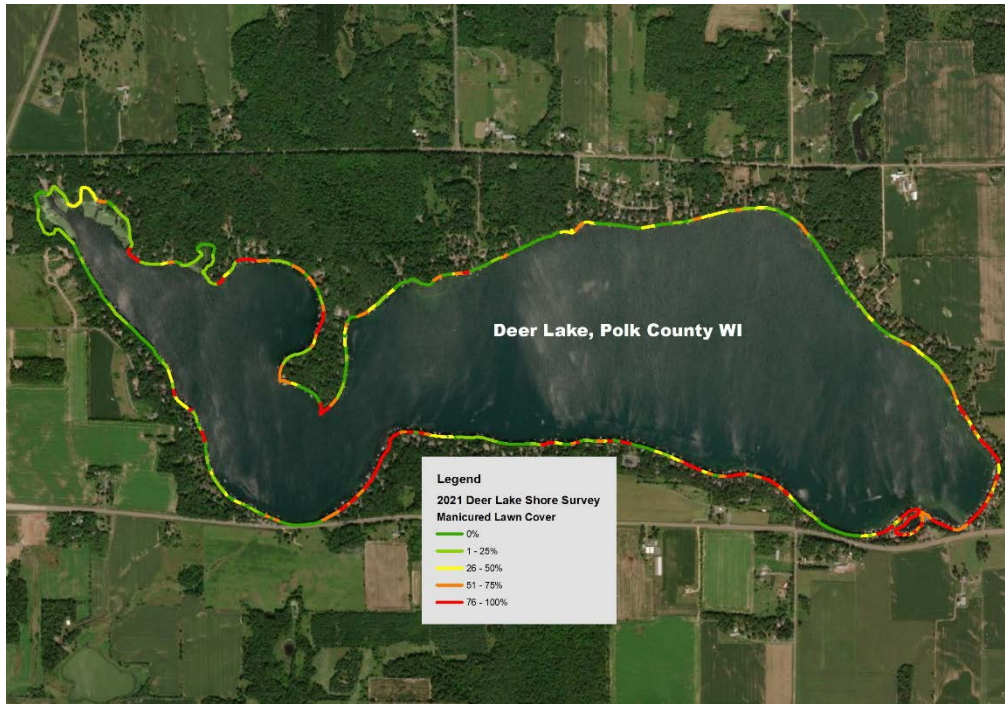
Manicured lawn ground cover: Manicured lawns are less effective in reducing runoff due to limited root structure, shorter height, and fertilization. This can increase runoff and nutrient loading.

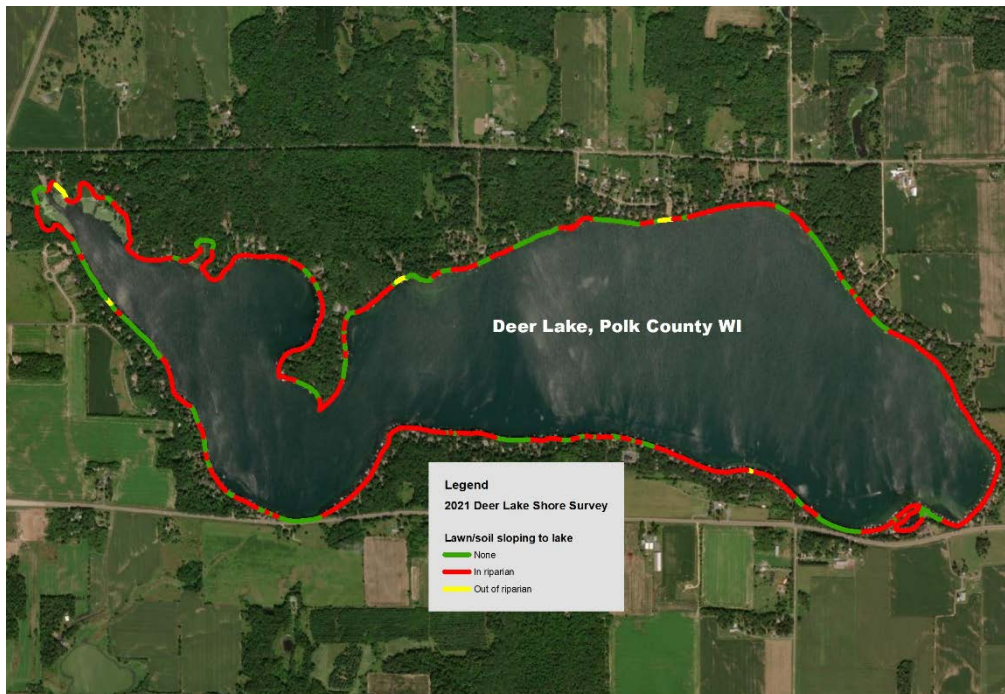
Lawn/soil sloping directly to the lake: If the land cover includes lawn sloping or exposed soil on a slope that runs now to the lake can increase runoff and nutrient loading compared to natural ground cover.

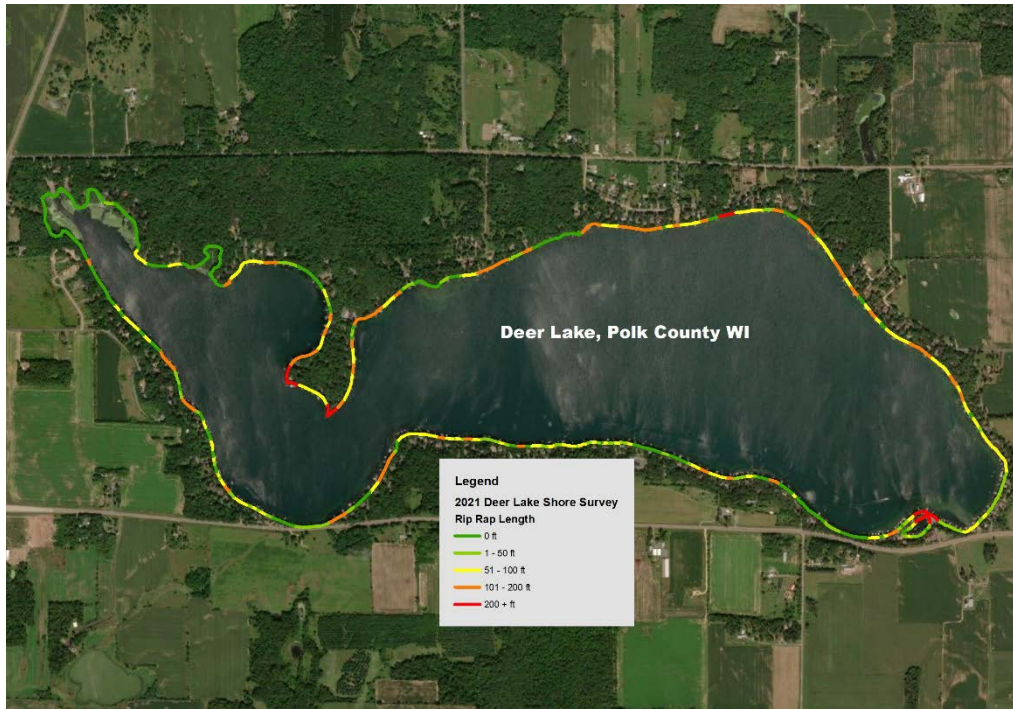
Riprap: Riprap on a bank can be positive by reducing bank erosion. However, rip rap can also reduce shoreline habitat for various organisms.

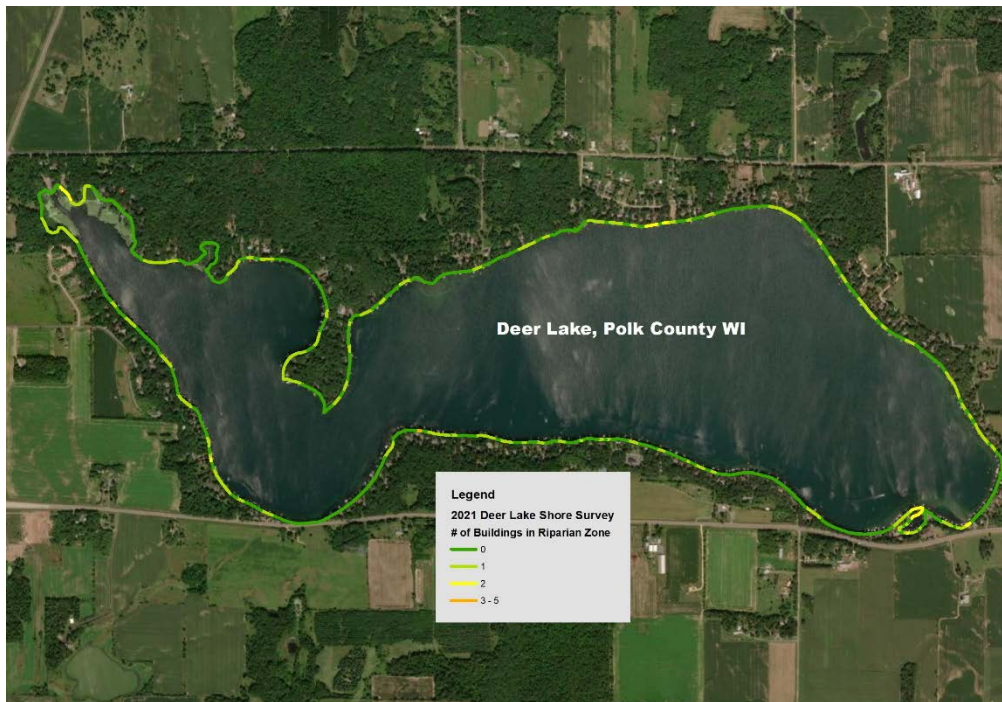
Buildings in the riparian zone: Buildings increase impervious surfaces with the roof. These structures can increase runoff.

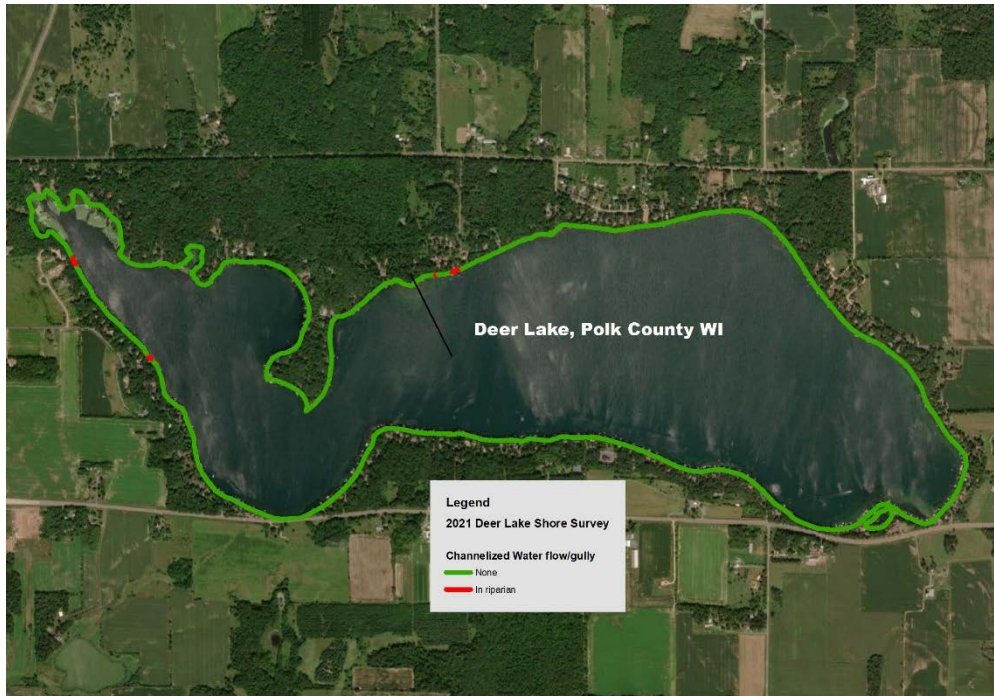
Channelized flow: Gullies or channels can form if the runoff is intense and the substrate is not stable. This indicates increased runoff and potential nutrient loading.

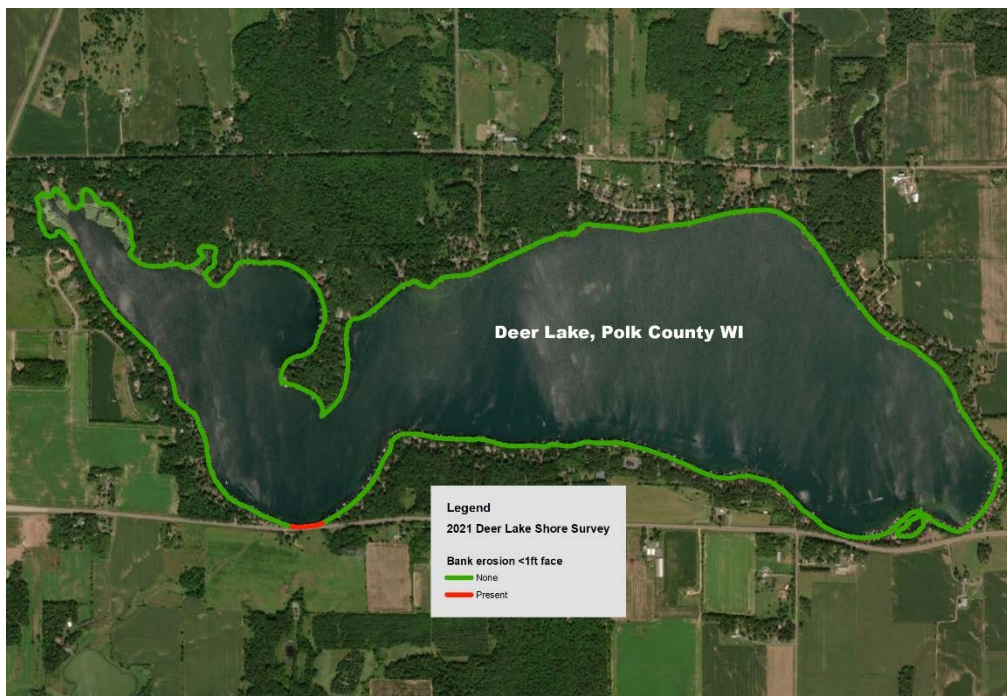
Bank erosion with < 1 ft face: Erosion of the lake bank can increase sedimentation and nutrient loading since sediment often has phosphorus bound. If the face is less than 1ft indicates less erosion (likely) than if the face is greater than 1 ft. There was NO parcel with bank face erosion > 1 ft face.
