Deer Lake Conservancy Report

Summer Edition

JULY 2012

Deer Lake Water Quality Improvements

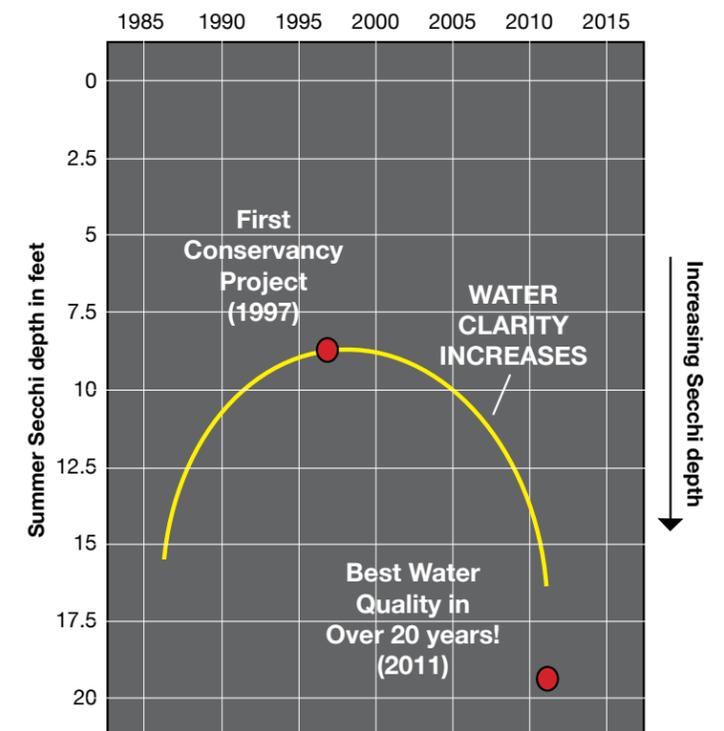
Deer Lake Secchi Depth Trend

The graph shows the trend in secchi depth measurements from 1987 to 2011. For best comparison between years, only average July and August measurements are used. Higher numbers mean greater water clarity – the disk descended deeper before it was not visible.

The graph is striking in that it shows that the trend in water quality improvement began in about 1997 when the first large project was completed in Watershed 2. This trend continues to 2011 when the highest water clarity was recorded in Deer Lake!

Water clarity in Deer Lake broke all previous records with an average July and August Secchi depth in the East Basin of almost 20 feet! The West Basin was close behind with an average depth of 17.5 feet.

With almost 25 years of measurement and over 15 years of Conservancy projects, a significant trend in water clarity is demonstrating the success of Deer Lake Conservancy projects! Algae growth and water clarity fluctuate from year to year because of rainfall, temperature, and other factors. As a result, it can be difficult to show changes in the span of a few years. The graphed line smoothes out these fluctuations and a distinct trend of water clarity improvement emerges since the Conservancy began!

Deer Lake Improvement Association volunteers have tracked water clarity in Deer Lake since 1987. Water clarity is measured using a Secchi disk. A Secchi depth measurement is recorded when the black and white disk is no longer visible as it is lowered toward the lake bottom. Dave Boumann and his family are currently taking Secchi measurements in the East and West Basins of Deer Lake.
